## Test report

**Test report Ref. N°:** 0760/17219971/12

**Subject matter of the order:** Testing of long term durability of roof water-proofing membrane types SGLaminat and SGtan

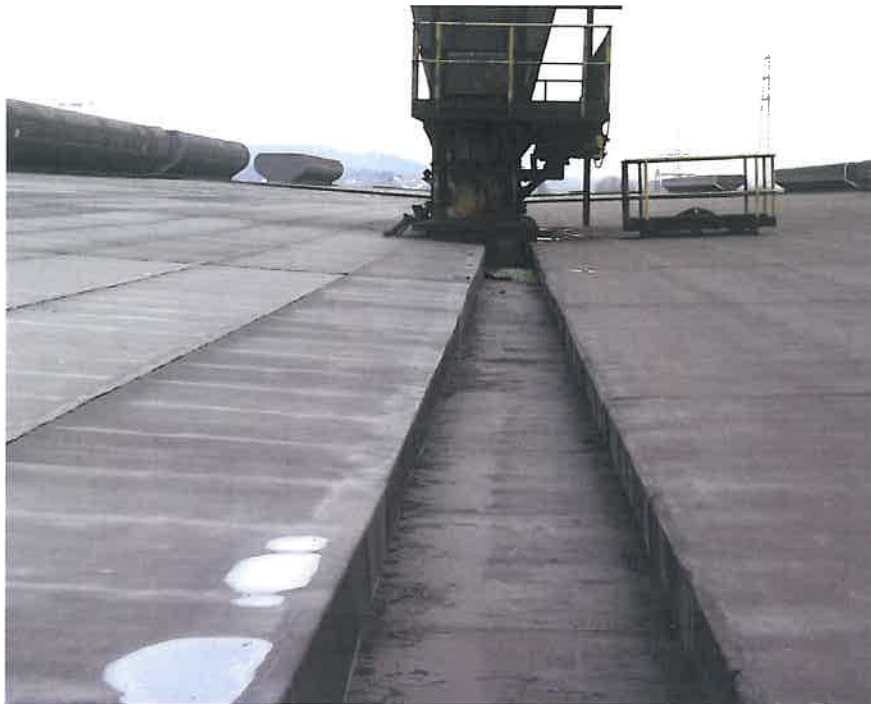
0404A01158

**Fig. 1:** General photograph of the channel of the Dillinger Hütte building after 29 years in place; no signs of shrinkage stresses

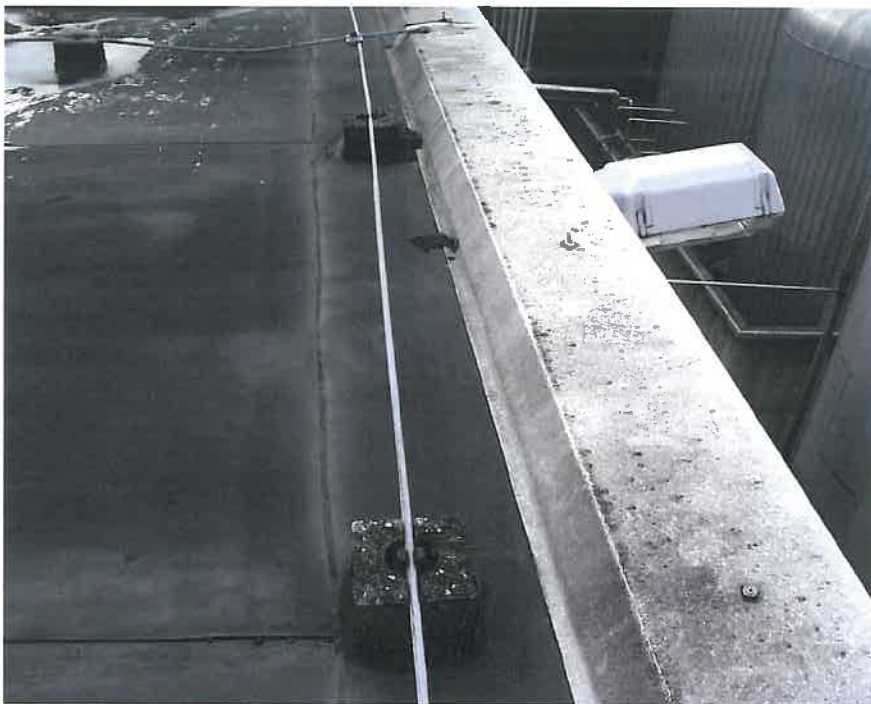
0404A01153

**Fig. 2:** General photograph of the roof parapet of the Karlsberg Brewery building at Homburg after 28 years in place; only slight signs of shrinkage stresses

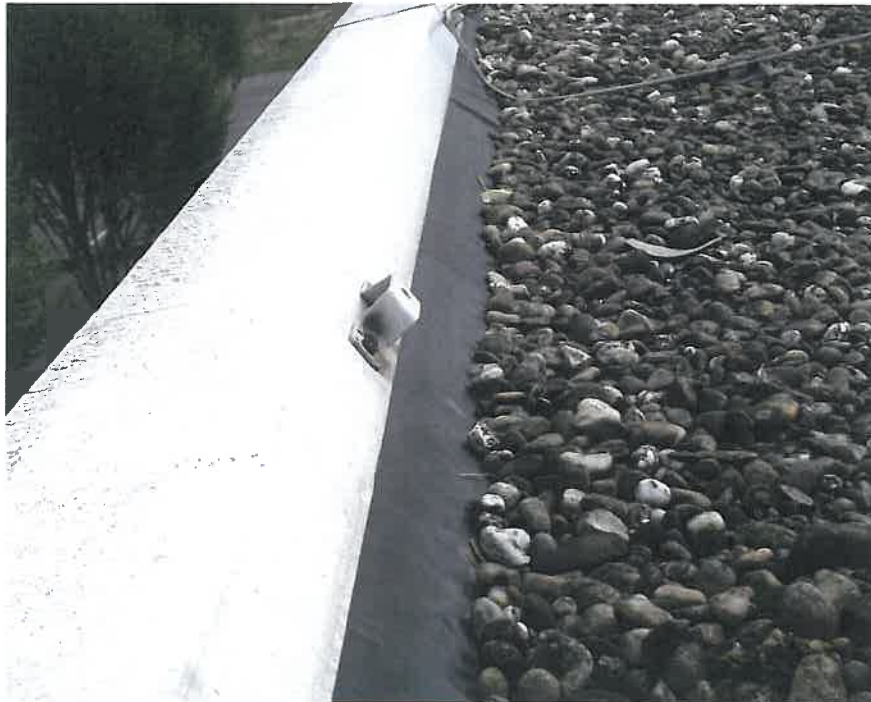
0404A01134

**Fig. 3:** General photograph of the roof parapet of the Swimming Baths Building at Wadern after 30 years in place; no signs of shrinkage stresses

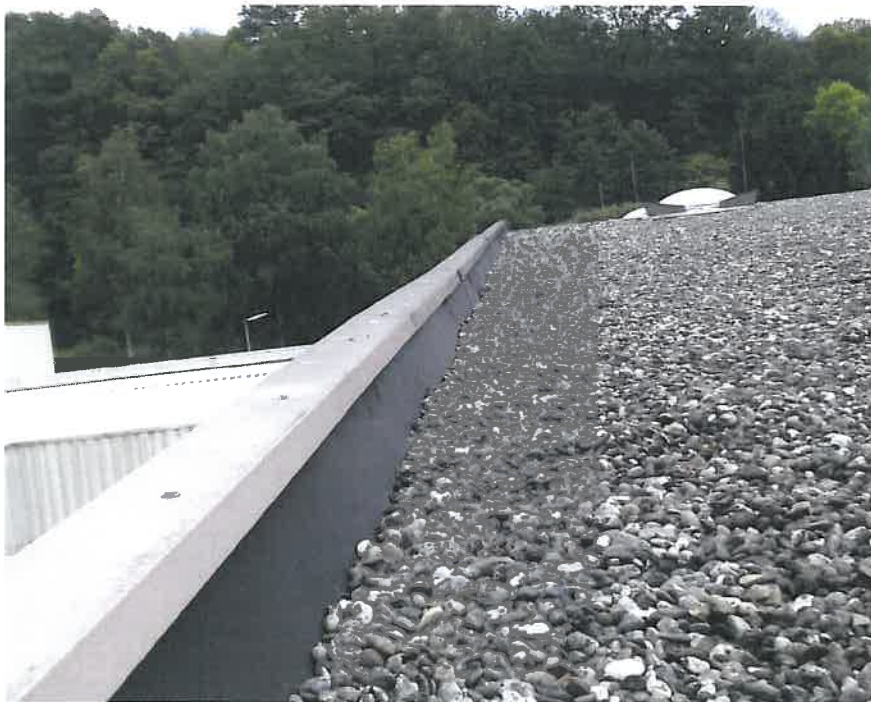
0404A01124

**Fig. 4:** General photograph of the roof parapet of the Army Building at Primstal after 27 years in place; no signs of shrinkage stresses

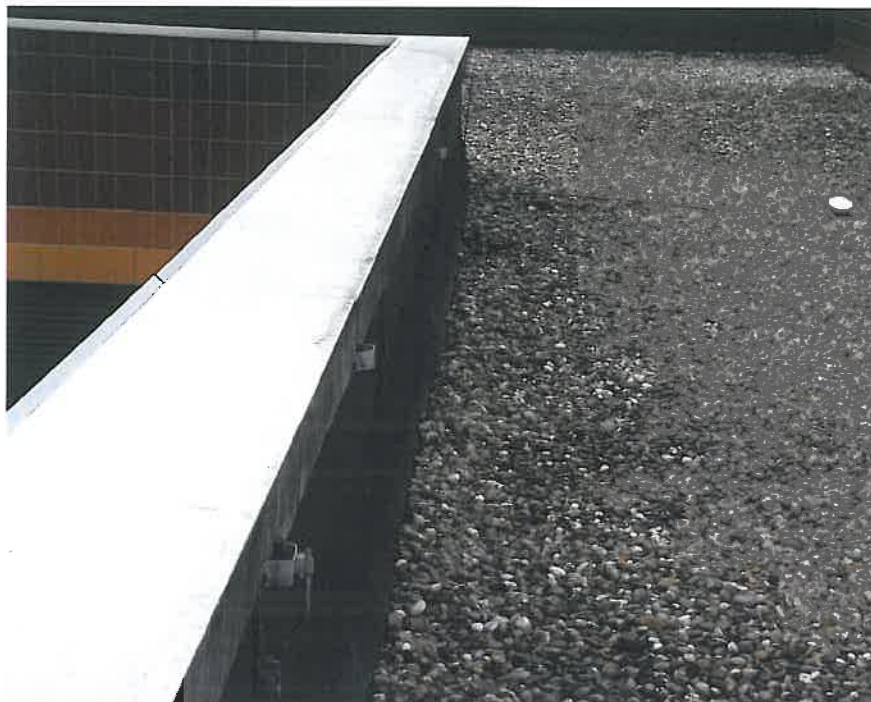
0404A01162

**Fig. 5:** General photograph of the roof parapet of the Training Centre Building at Wadern after 30 years in place; no signs of shrinkage stresses

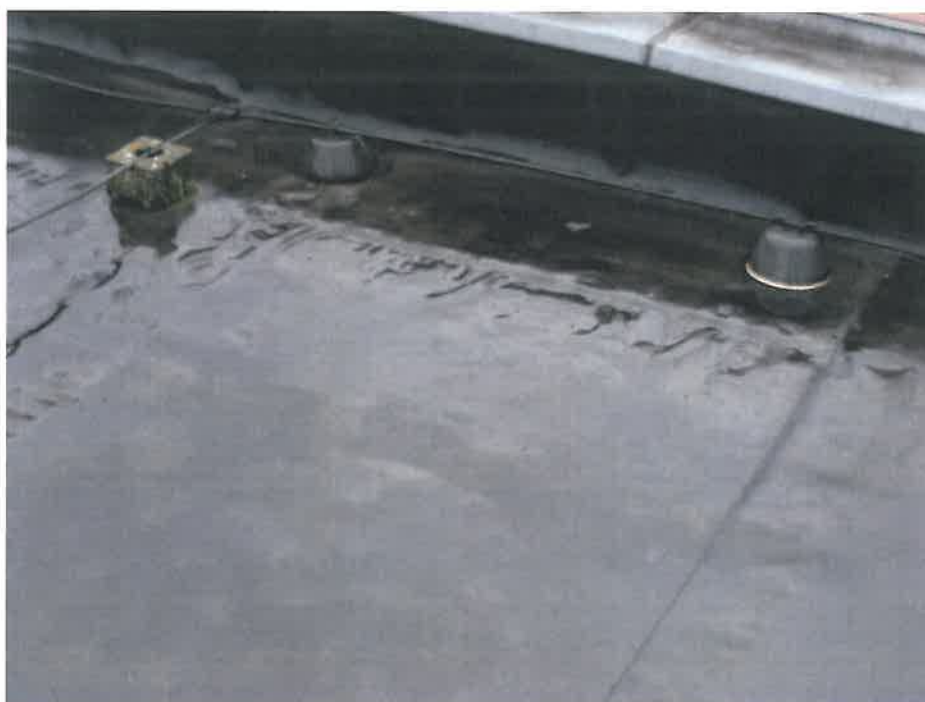
0404A01162

**Fig 6:** General photograph of the roof parapet of Saar Gummi hall 22 after 36 years in place; no signs of shrinkage stresses
