## Test report

**Test report Ref. N°:** 0760/17219971/12

**Subject matter of the order:** Testing of long term durability of roof water-proofing membrane types SGLaminat and SGtan

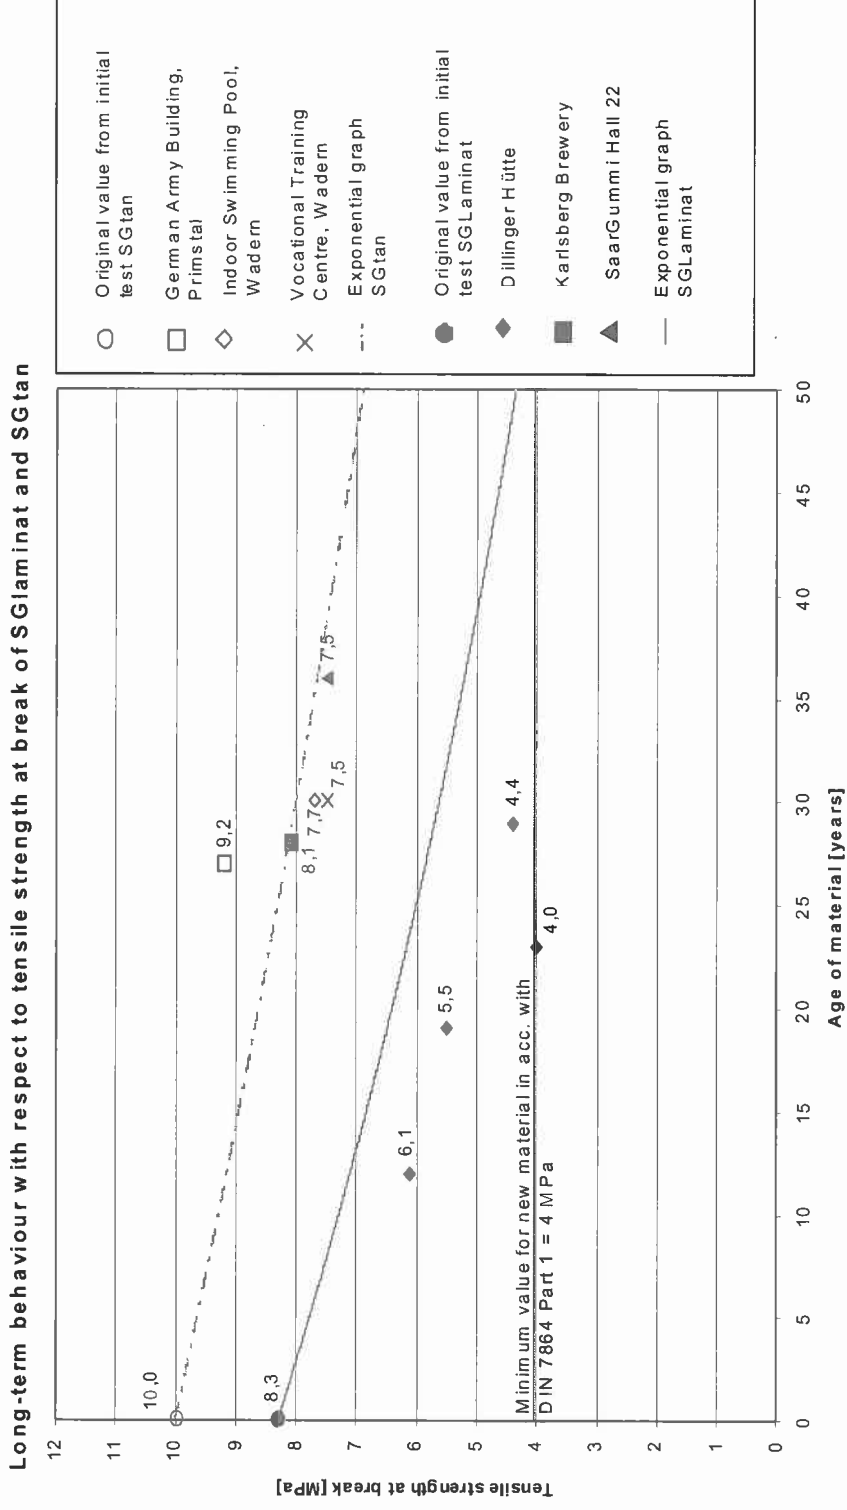
**Fig. 1:** Graph of tearing stress against age of material

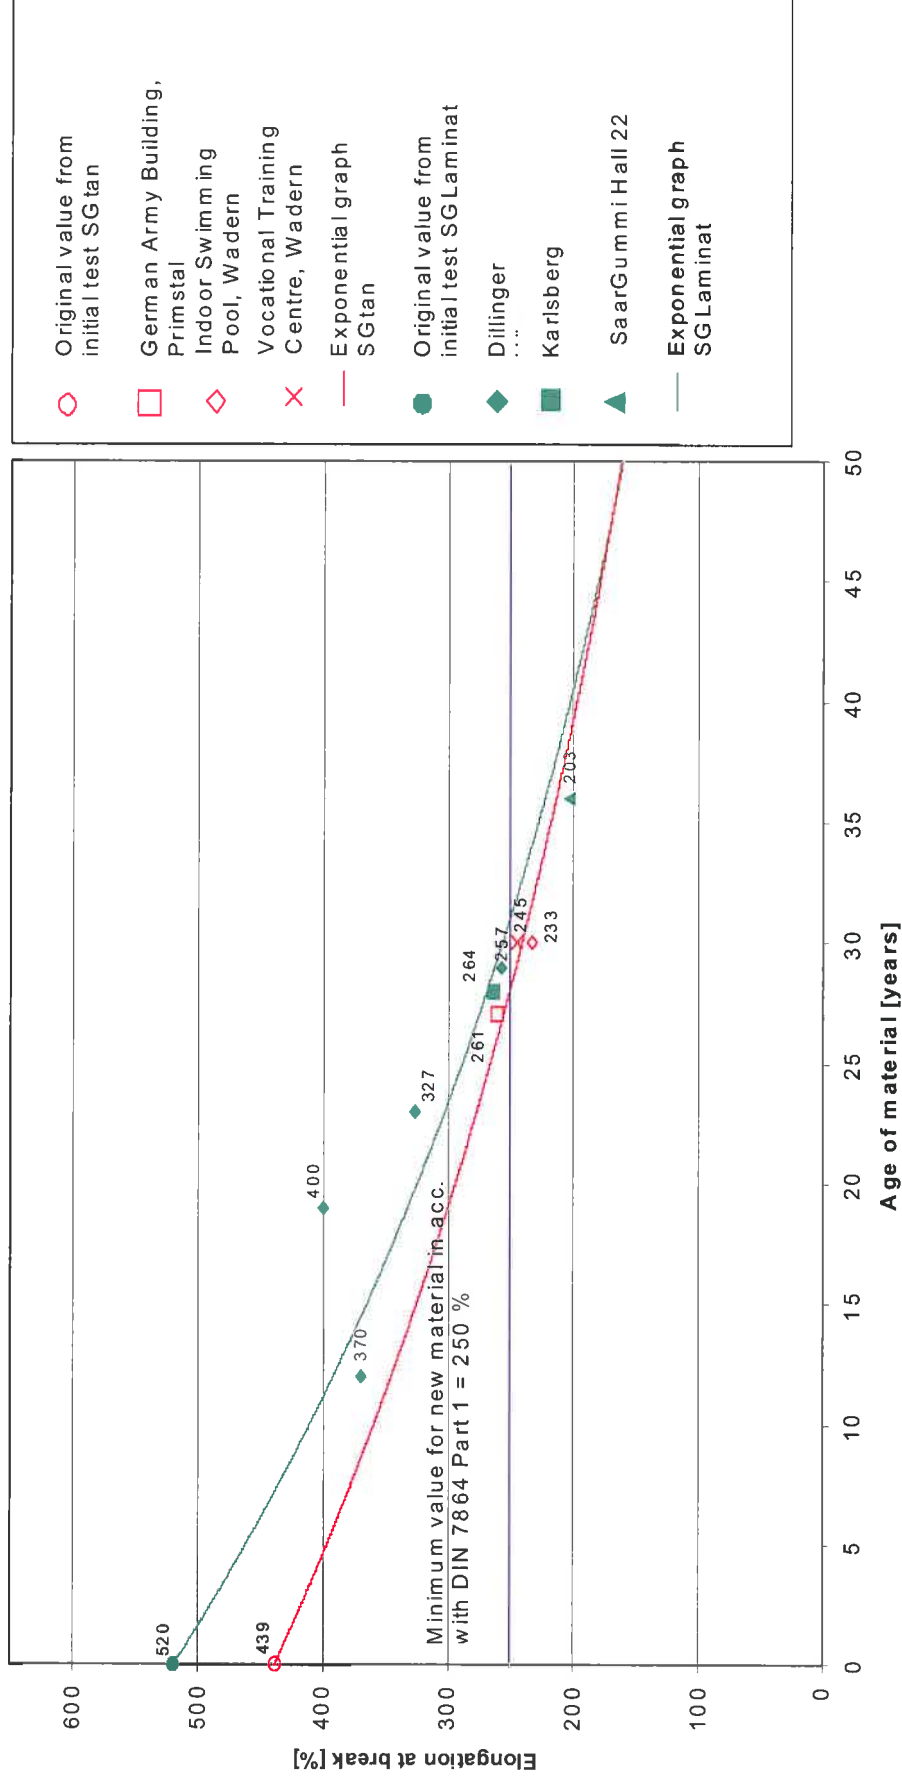
Long-term behaviour with respect to elongation at break of SGLaminat and SGtan

Fig. 2: Graph of elongation at break against age of material
